Illinois River Watershed Implementation Program

**FY 1996 319(h) Task 240
C9-996100-04**

Best Management Practices Implemented on Peacheater Creek

**Oklahoma Conservation Commission
Water Quality Division**

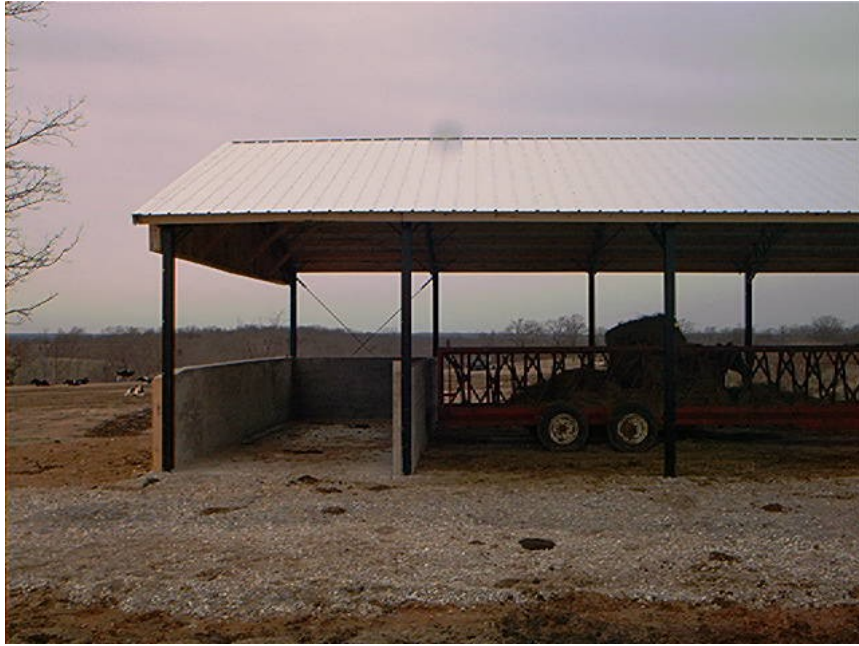
Figure 1: Feeding facility with dry stack.

Waste storage facilities are built to contain agricultural waste (including manure, wastewater, and contaminated runoff) temporarily (NRCS, 2002a). Paving areas allows for easier cleaning of the waste. Manure is stored as a liquid in ponds or lagoons, as a semi-solid in an open container that drains into a lagoon, or in its solid form in a roofed dry stacking structure. Dry stacking waste allows for composting (Figures 1 and 2). In addition to use as fertilizer, the dry waste is utilized in combination with other materials as livestock bedding (NRCS, 1992). Feeding and watering areas receive much use by livestock causing increased deposition of waste materials and erosion (Figure 3). By confining livestock to specified feeding and watering areas, the impact of the waste is more easily controlled, allowing less waste to reach water bodies (Figures 4 through 9). By excluding livestock from areas and by containing livestock waste, sources for nutrient enrichment and pathogen exposure to a stream are decreased (Novotny and Olem, 1993).

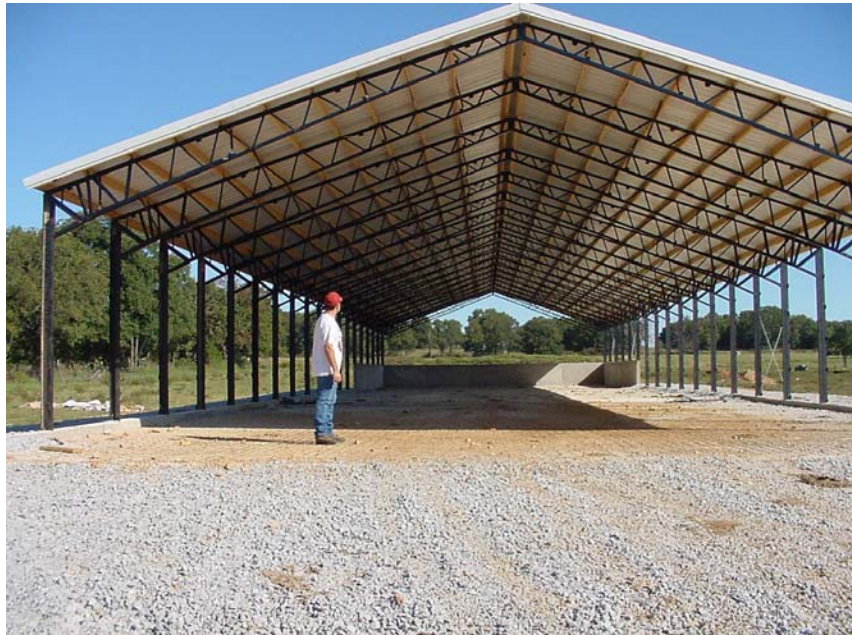
Figure 2. Inside of feeding facility showing dry stack on the end.

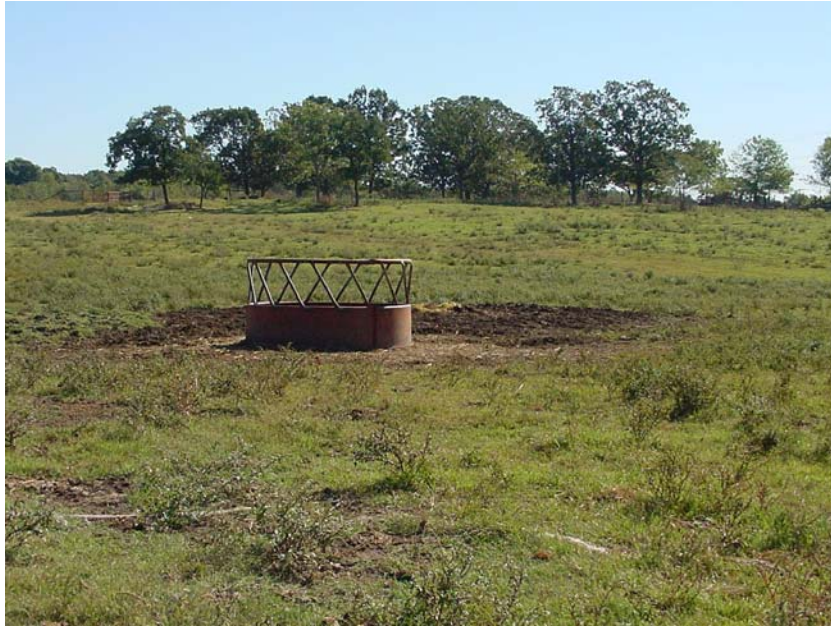
Figure 3. Area exposed to excess waste and erosion. This problem is corrected by building the feeding facilities.

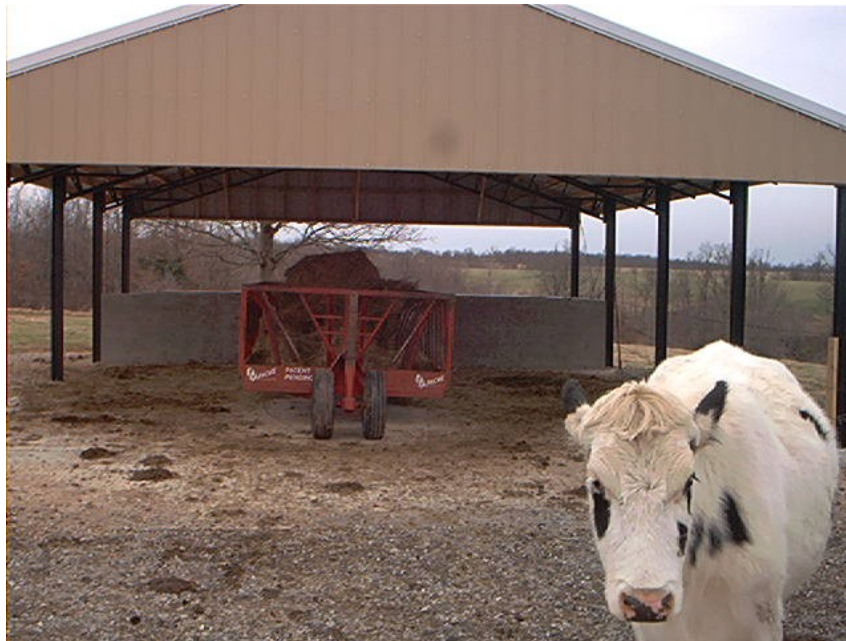
Figure 4. Beef cattle feeding shed.

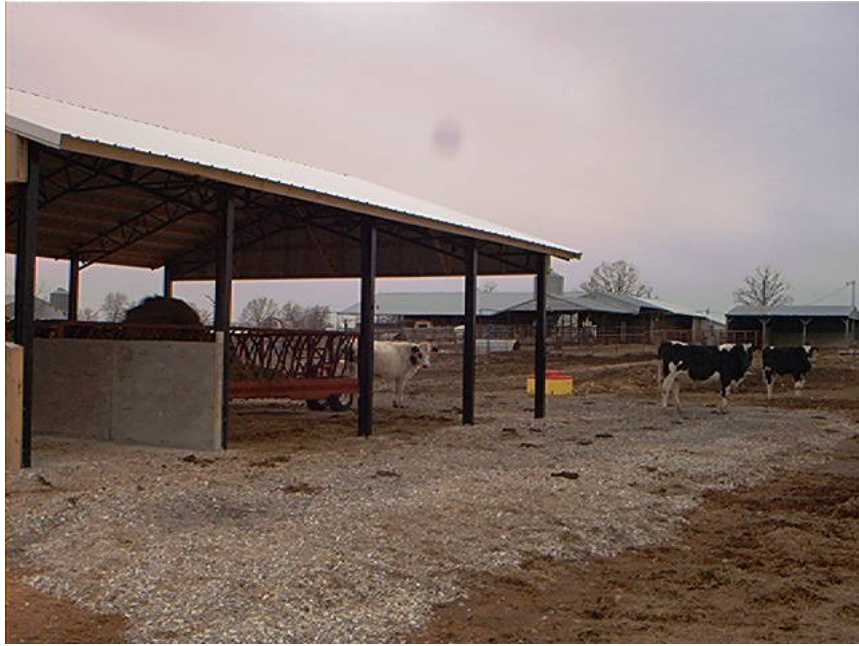
Figure 5. Another view of the beef cattle feeding shed.

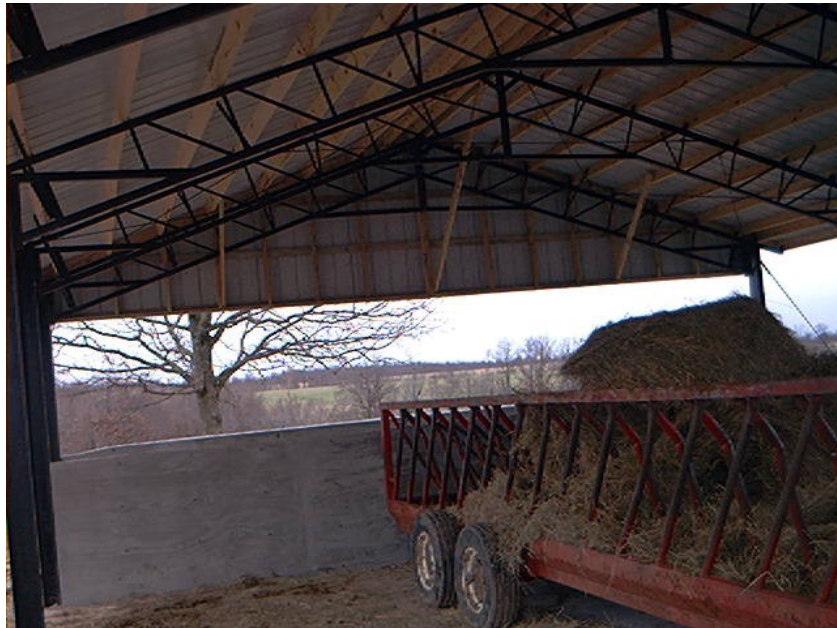
Figure 6. Beef cattle feeding shed.

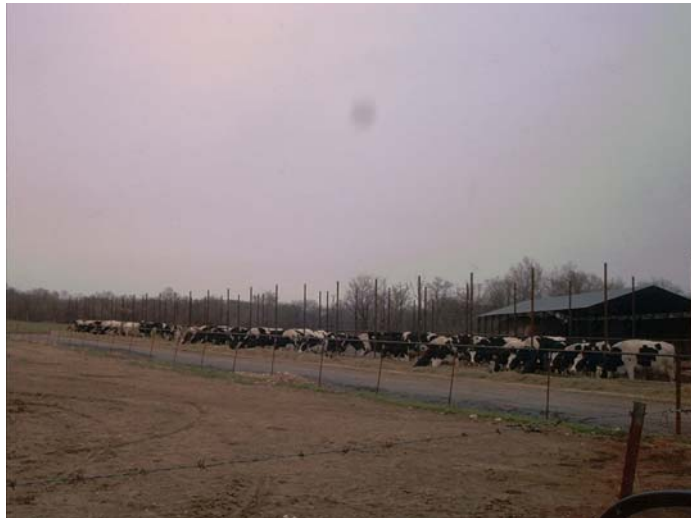
Figure 7. Dairy feeding floor.

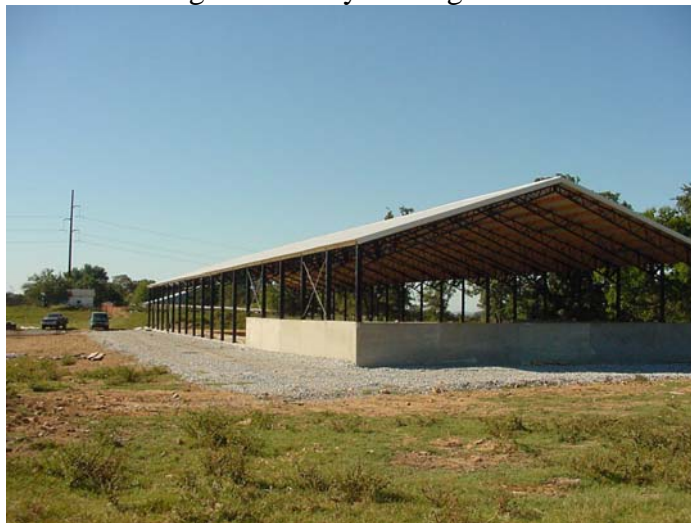
Figure 9. Large dairy feeding facility.

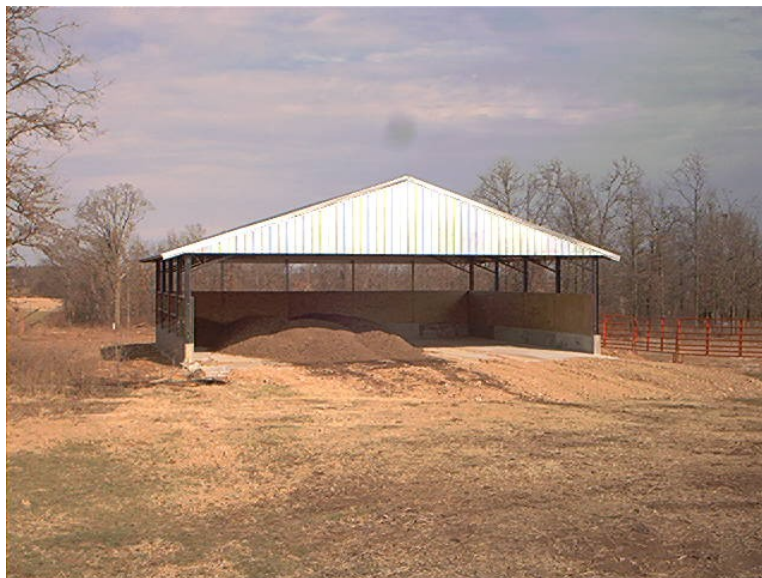
Figure 10: Poultry waste dry stack.

When exposed, poultry litter will lose nitrogen to the air as ammonium. Exposed litter is also vulnerable to runoff events after rainfall. This subjects both groundwater and surface water to pollution. Proper storage ensures that the fertilizer applied to land has improved nutrient retention, as the litter will not have been as exposed to the elements. Leaching of nutrients into ground water can be hindered by use of a ground liner; however, a permanent structure built to contain dry litter is often a better storage choice. These buildings usually have roofs and concrete floors to protect the litter from the elements in addition to protecting groundwater from nutrient leaching (Figure 10). The height of the roof is important, as it should offer enough space for litter to be piled and the equipment to be used. Partial walls may enclose the structure to prevent wind and rain from having an impact on the litter. Interior posts should be avoided as they impede activity in storing and removing the litter (Cunningham et al., 2003).

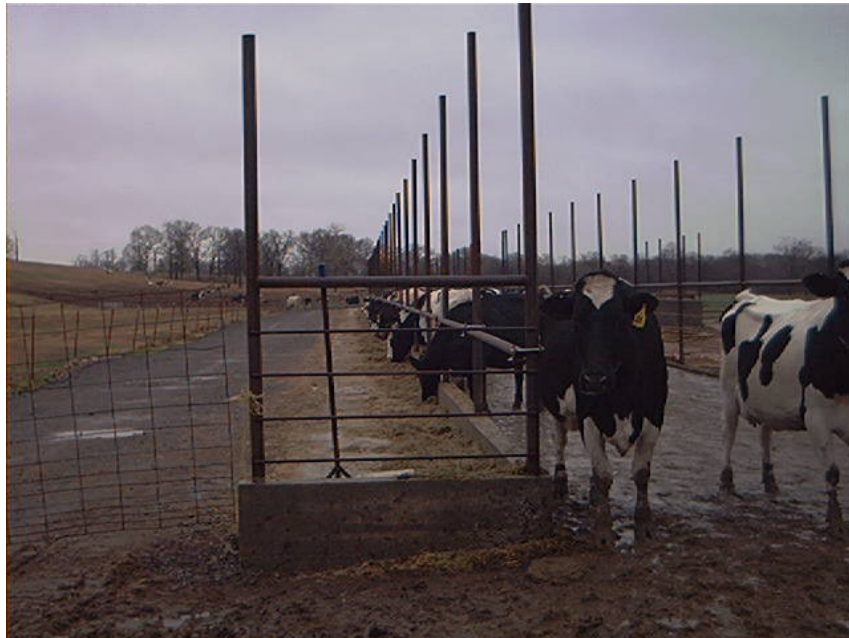
Figure 11. Dairy feeding facility with auto waterer and travelways from pasture to milking parlor.

Travel ways allow controlled animal movement to specified foraging areas, watering sites and shelters, protecting areas from erosion and pollution (Figure 11) (NRCS and NHCP, 2002). Watering and feeding facilities protect livestock from disease, offer animals safer areas for eating and drinking while protecting areas from erosion and streams and ponds from sediment and bacterial pollution (NRCS and NHCP, 2000). Use of watering tanks improves water quality both for the animals as well as for streams; the animals are no longer contaminating their water supply and the stream experiences reduced pollution and stream bank erosion allowing for an improved riparian area (Burns, 2003). In a similar way, excavating ponds provides an alternative source of water from streams. The pond can also be fenced off with the pond water being piped to tanks, thus protecting the pond from contamination and erosion. Both insulated tanks and electric heaters can be used to freeze-proof the water supply (Figure 12).

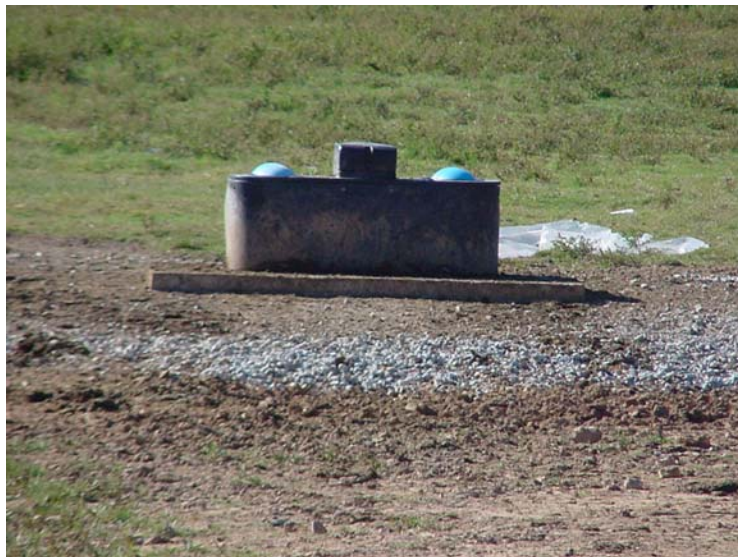
Figure 12. Automatic waterer for large feeding facility.
